## Georgia-Pacific LLC

Plainwell No. 2 Dam Area Fall 2013 Bank Repair Plan Technical Memorandum

GEORGIA-PACIFIC LLC  
ALLIED PAPER, INC./PORTAGE CREEK/  
KALAMAZOO RIVER SUPERFUND SITE  
**PLAINWELL NO. 2 DAM AREA**  
**FALL 2013 BANK REPAIR PLAN TECHNICAL MEMORANDUM**

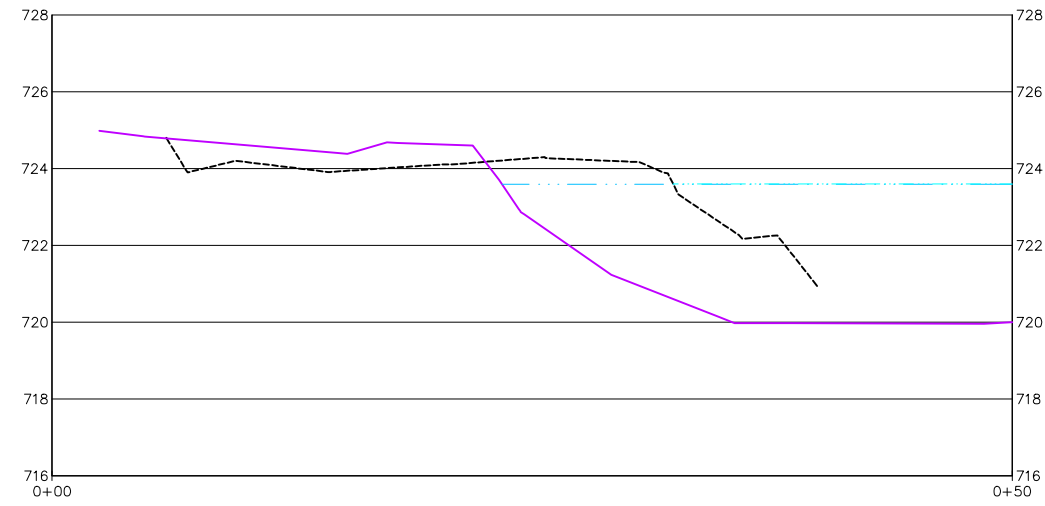
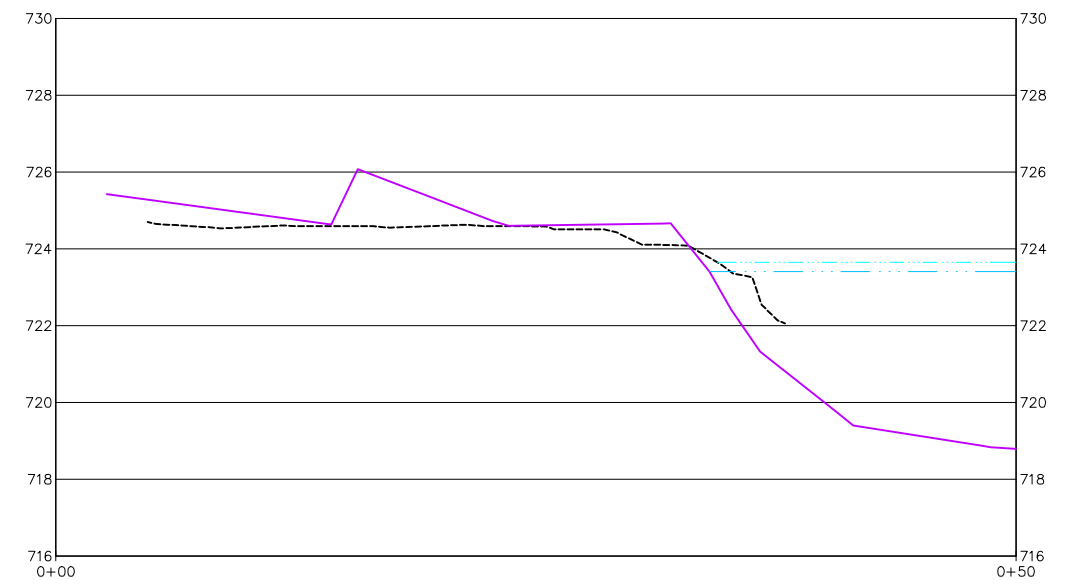
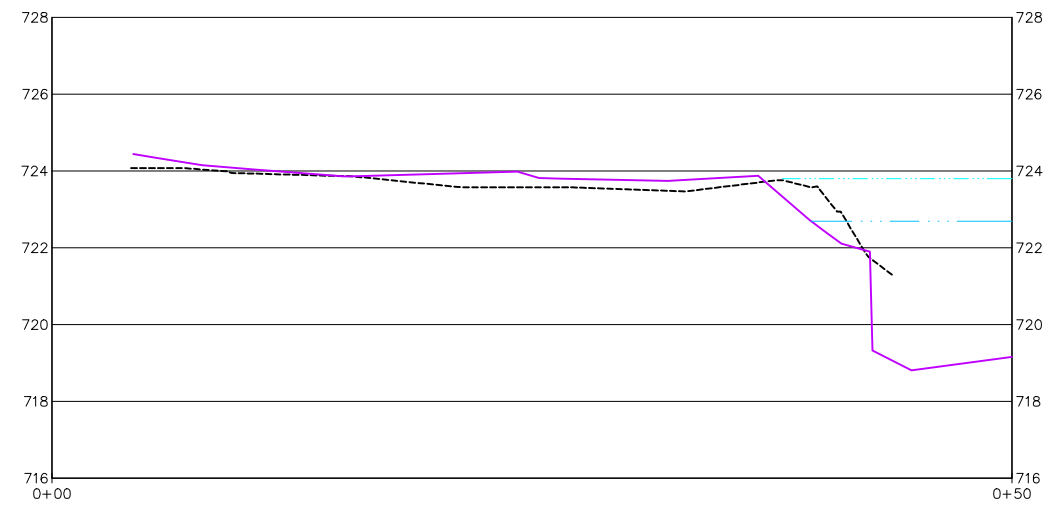
## PLAINWELL NO. 2 DAM AREA BANK PROFILE TRANSECTS

The results of bank profile survey (Figure 3) were submitted to USEPA and MDEQ in the Spring 2013 BCMR (ARCADIS 2013a). Based upon review of the bank profile survey cross-sections, Georgia-Pacific and ARCADIS concluded that three of the four bank areas required maintenance to minimize the potential for future erosion (ARCADIS 2013a).

During the Agency Annual Site Inspection, four areas were identified by USEPA and MDEQ as exhibiting signs of erosion. Following review of post-construction and newly surveyed bank profiles of these areas, three of the areas (Removal Areas 2, 3A, and 4A) were identified as requiring repairs and are addressed in this memorandum.

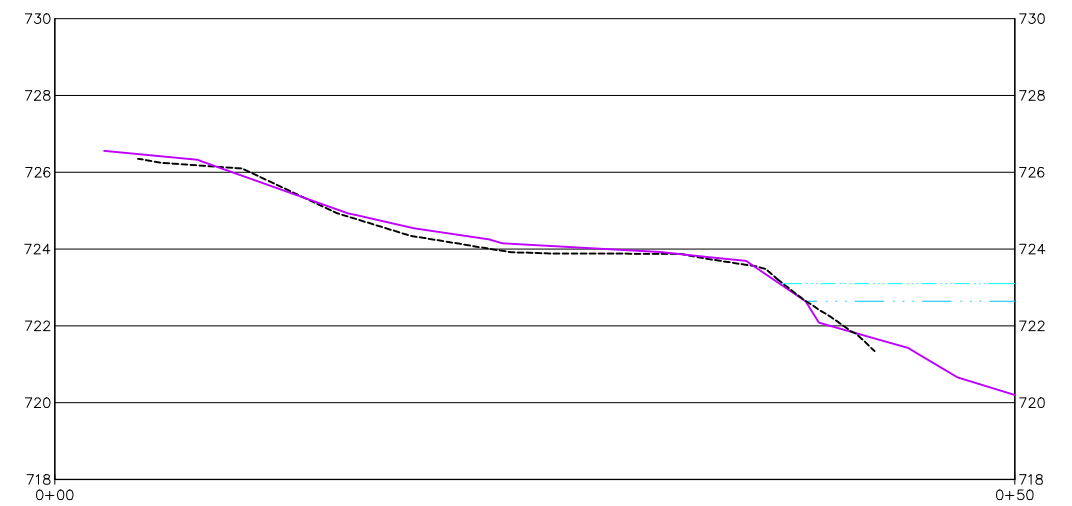
**T-18**

USEPA and MDEQ also identified a fourth area - Removal Area 4B - as exhibiting signs of erosion; however, based upon evaluation of the bank profile survey data, the current bank slope in Removal Area 4B (Figure 3; T-18) is very similar to the post-construction condition. No significant erosion appears to have occurred at this location; and therefore, bank repair is not warranted in this area.
